Lincoln National Forest | July 2024

South Fork Fire Burned Area Summary

Burned Area Report

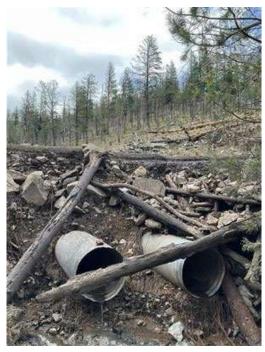
NFSR 127A Roadway Embankment Erosion

Critical values addressed in the BAER report include NFS roads and related drainage features. Treatments for the protection of these roads include stabilization and armoring of roadway embankments located at drainage crossings, three in total, to prevent roadway failure. Removal of accumulated debris in affected drainages will also be considered so they can continue to function as intended and direct stormwater flows away from Forest Service Road 127A.

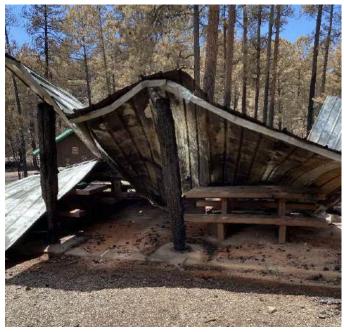
Sam Tobias Group Campground, Oak Grove Campground, and Cedar Creek Picnic Area all experienced damages and losses from the fire. Additional damages occurred at Sam Tobias Group Campground and Cedar Creek Picnic Area in post-fire flooding due to increased runoff. Emergency treatment recommendations for these sites include facility safety work to clean and remove recreation facilities that were damaged or destroyed in the fire.

Figure 2: Recreation facility damaged during the fire at Sam Tobias Group Campground
